**Confidential Inspection Report**  
**5 Brownstone St.**  
**Brooklyn, NY 11233**

**Prepared for: Mr. Frank**

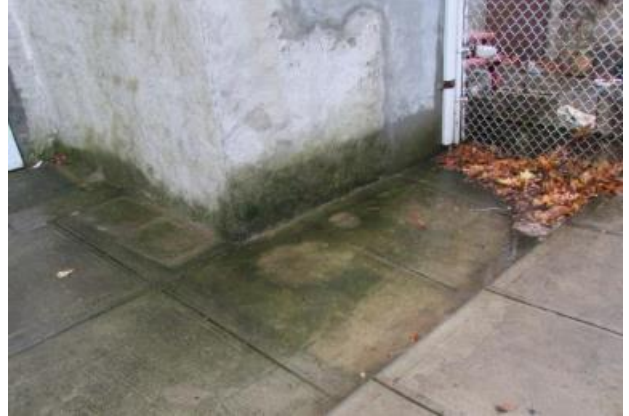
The drain needs repairs by a licensed qualified contractor and / or plumber. Inspector noted accumulation of leaves and water near the drainage areas.

The current drainage system does not appear adequate to remove water that accumulates at the rear walkout and patio area and water can enter into the structure. An adequate drain that is connected to the sewer system needs to be installed.

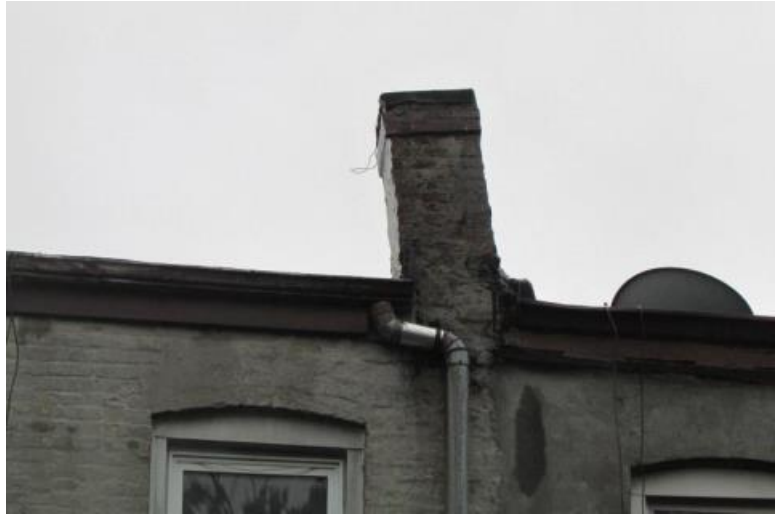
The chimney stack / flue was tilted excessively. The current condition may adversely affect the exhaust of the combustion products causing them to re-enter the home. Moreover the brick flue may fall over causing damage to a passerby. Immediate safety concern. The services of a licensed reputable contractor is recommended.

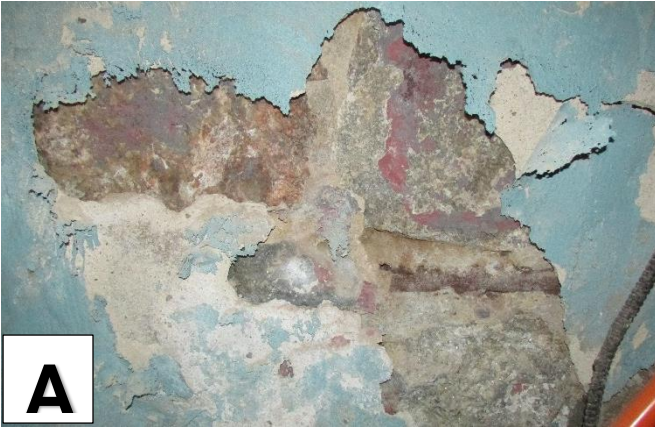
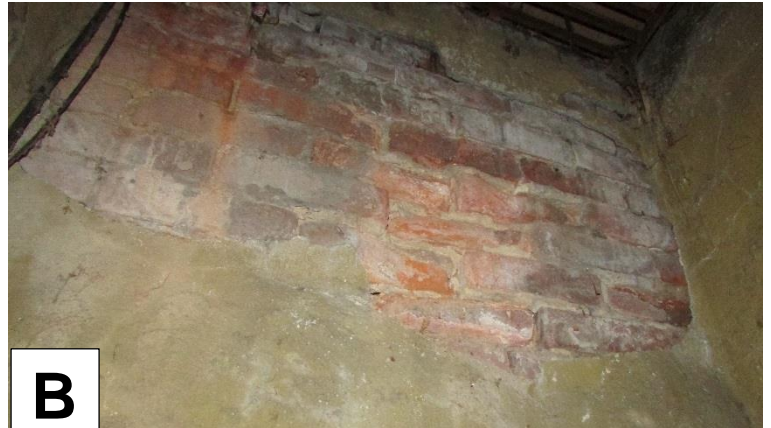
**The foundation was in need of a reputable contractor to perform immediate repairs.**

Stone foundation wall -

- Areas where there was missing mortar.
- Areas that had sand oozing out of the foundation and were disintegrating.

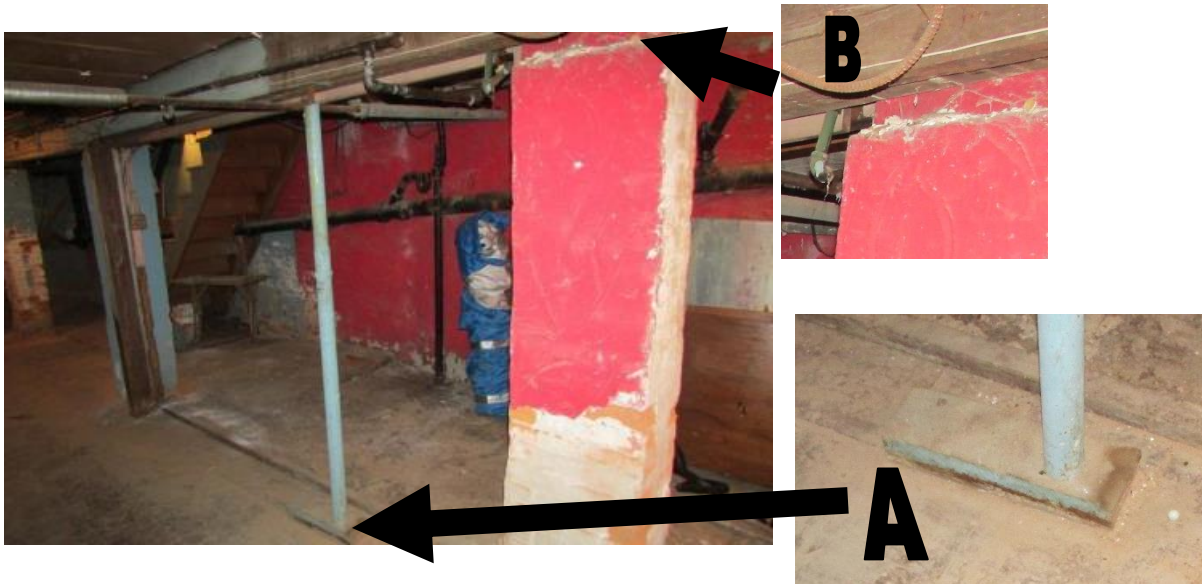
**Action Necessary** - There is a post installed in the basement that requires some form of repair or replacement. Inspector noted that the brick post was spalling at several areas, there were wood shims used at the areas between the post and the main beam.

**There is a condition that is not consistent with generally recommended practice and evaluation by a qualified licensed structural engineer or contractor is needed prior to closing.**

- A. There is an additional temporary jack post that is not meant for permanent support - the screw-jack type posts, are recommended for temporary support only. The post does not have footing and is placed on a wood plate. There is a possibility that the wood plate can dislodge causing the structure to collapse. Installation of an adequate steel post (lolly) and adequate footing is recommended by a licensed reputable contractor.
- B. The beam the post is supporting is also wrong and has no support at one end. This area needs to be properly supported.

The wood post is prone to damage and should be replaced by a steel permanent nonadjustable post (lolly).

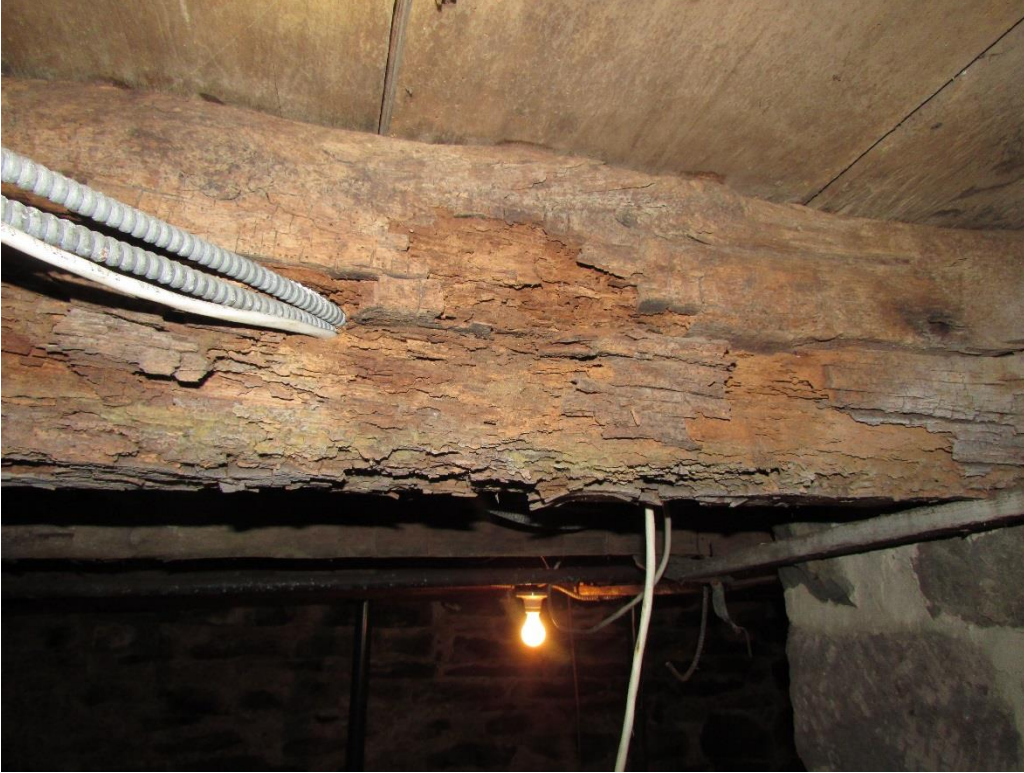
Inspector noted damaged wood at the front cellar joist near the sill plate. The damage appears to be from wood destroying insects as noted at the way it was damaged.

There was also wood frass / powder noted at the wood that was used as the main beam. The damage appears to be caused by wood destroying Insects. Further evaluation and treatment by a licensed 7C reputable mitigation company is recommended.

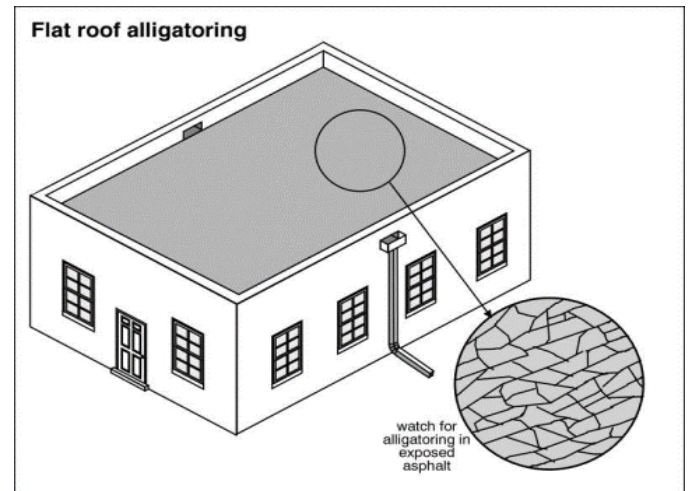
**Attention Needed** - The roof covering material shows signs of deterioration or damage that needs attention to prevent further deterioration or leakage.

- 1) Alligator skin noted especially at flashing areas.  
Alligator skin - the cover surface becomes brittle and cracks resulting in an appearance of alligator skin. These cracks may deepen and eventually allow water to enter the asphalt felt.
- 2) Air bubbles were noted in portions of the roof.  
Which may lead to soft areas that are more prone to damage.
