Confidential Inspection Report
High Ranch Rd.
Rockland County, NY

Prepared for: Mr. Jones

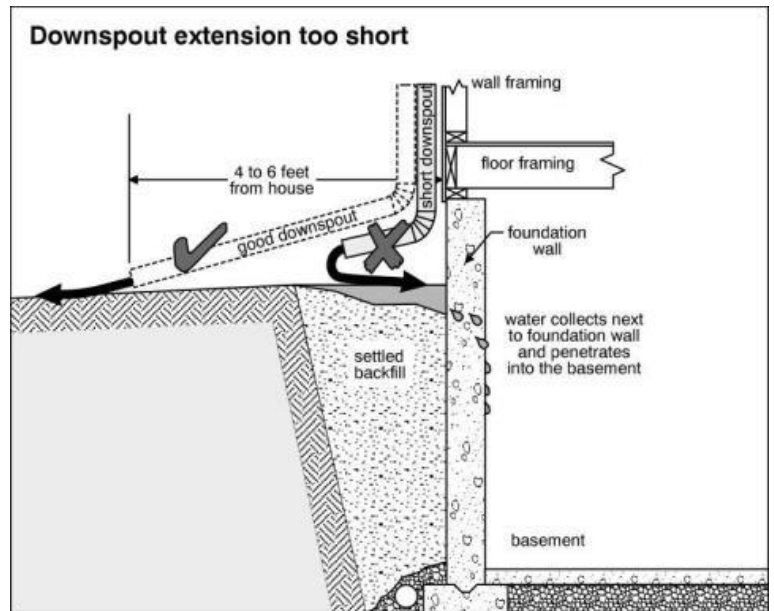
Run-off water needs to flow away from the side of the house at least 6 feet. This will allow the run-off to get far enough away to not interfere with the foundation. Installation of downspout extensions would help carry the water further away from the foundation.

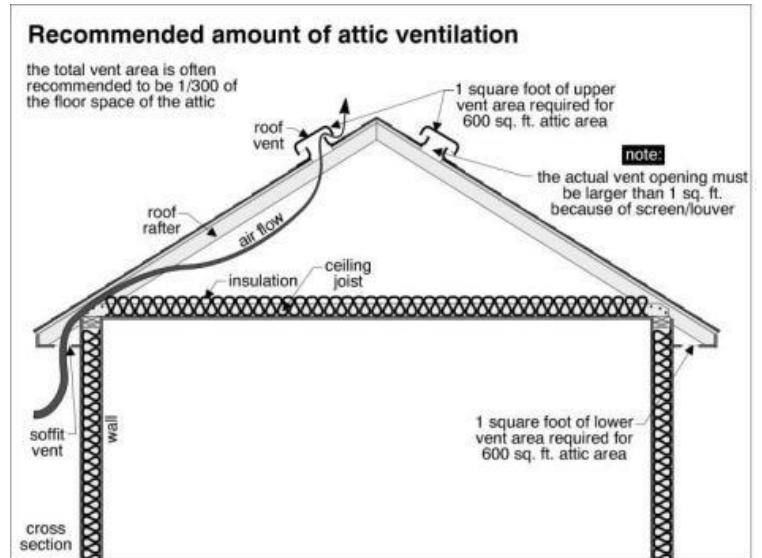
There are gable end vents installed. Gable vents alone may not provide adequate ventilation to attic. There was an attic fan installed which should facilitate air circulation. Current industry standards recommend, as a minimum, one square foot of free vent area for each 150 square feet of attic floor if no vapor barrier is installed. With a vapor barrier installed, one square foot of free vent area per 300 square feet of attic space is needed. Improper ventilation will keep the attic hotter in the summer months and colder in the winter season and may shorten the life expectancy of the asphalt shingles.

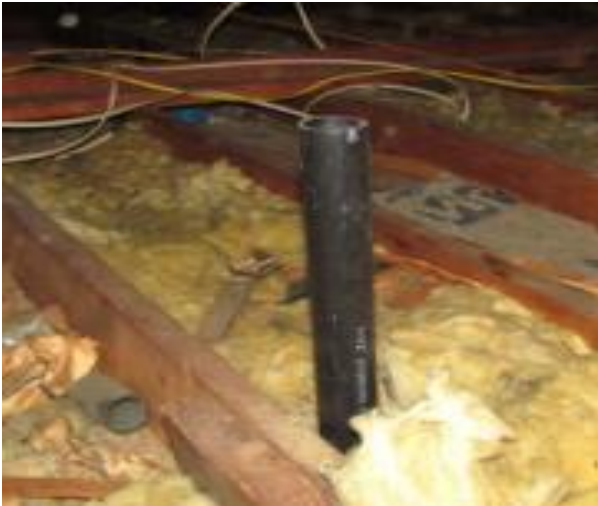
There appears to be a plumbing Vent in Attic. The plumbing vent should vent outdoors and not in the home. Sewage gasses can be a health hazard and because sewer gas contains methane gas (CH₄) there is a risk of an explosion hazard or even fatal asphyxiation. We recommend venting the plumbing vent to the exterior a licensed reputable contractor is recommended.
