Confidential Inspection Report
High Ranch Rd.
Rockland County, NY

Prepared for: Mr. Jones

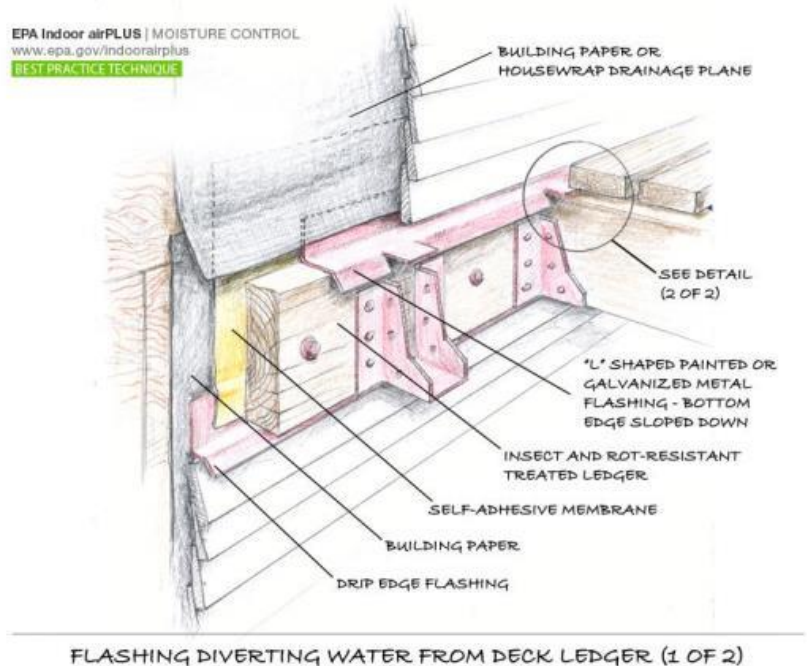
Inadequate flashing results in wetting and rot in the walls sheathing and framing. Proper flashing will maintain the integrity of the drainage plane and channel water away from the walls surface. We recommend the services of a licensed qualified contractor to install the proper flashing.

The diagram from the EPA demonstrates adequate ledger flashing.
